# CH<sub>2</sub> CASE STUDY

## 1200 BUILDINGS PROGRAM

Case study: Council House 2, 218-240 Little Collins St Melbourne

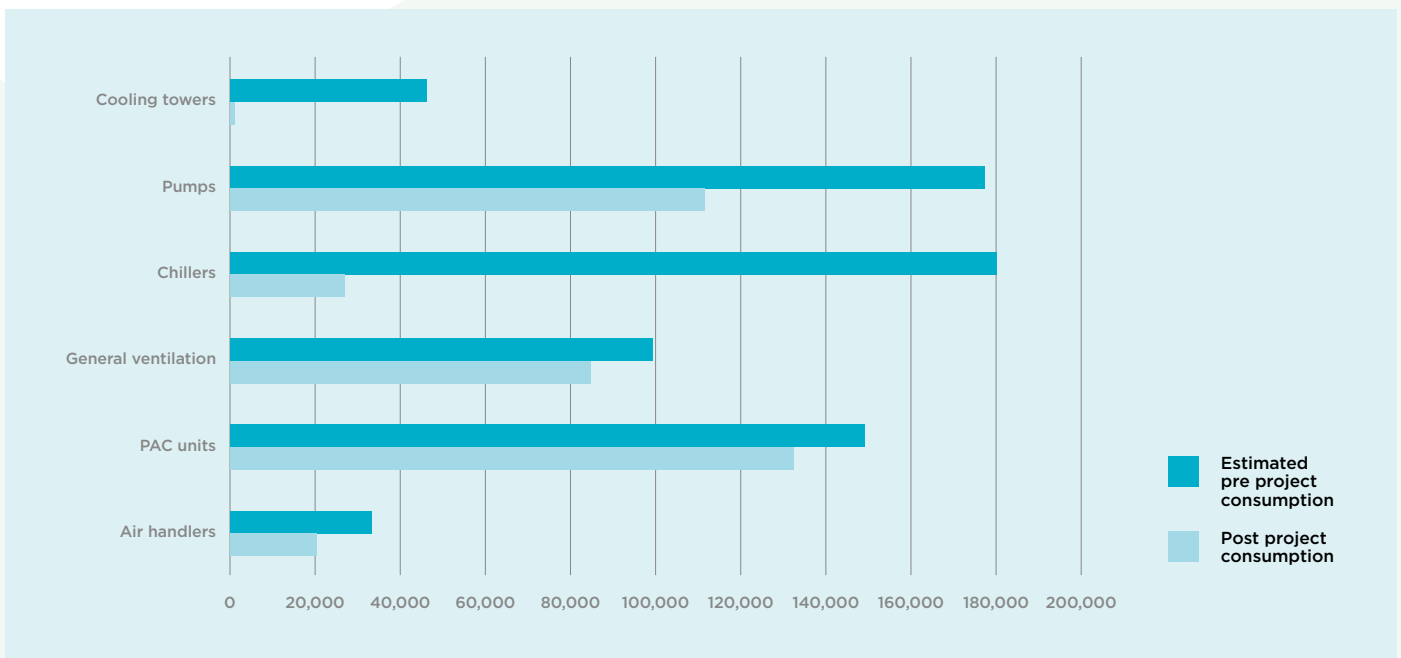
The graph below highlights that following works to the BMS, energy consumption fell significantly in the cooling towers and chillers, although some of the gains made in the chillers and pumps is due to the non-operation of the chilled panels. Energy consumption of the air handling units has improved despite the fact they have had to pick up the role of primary cooling in the absence of the chilled panels. Ancillary systems including the PAC units and ventilation fans now dominate the building's energy consumption (See Next steps section on the following page).
