6.0 CONSERVATION POLICY

This conservation policy has been developed on the basis of the preceding assessment and analysis of cultural heritage significance of the Melbourne City Baths.

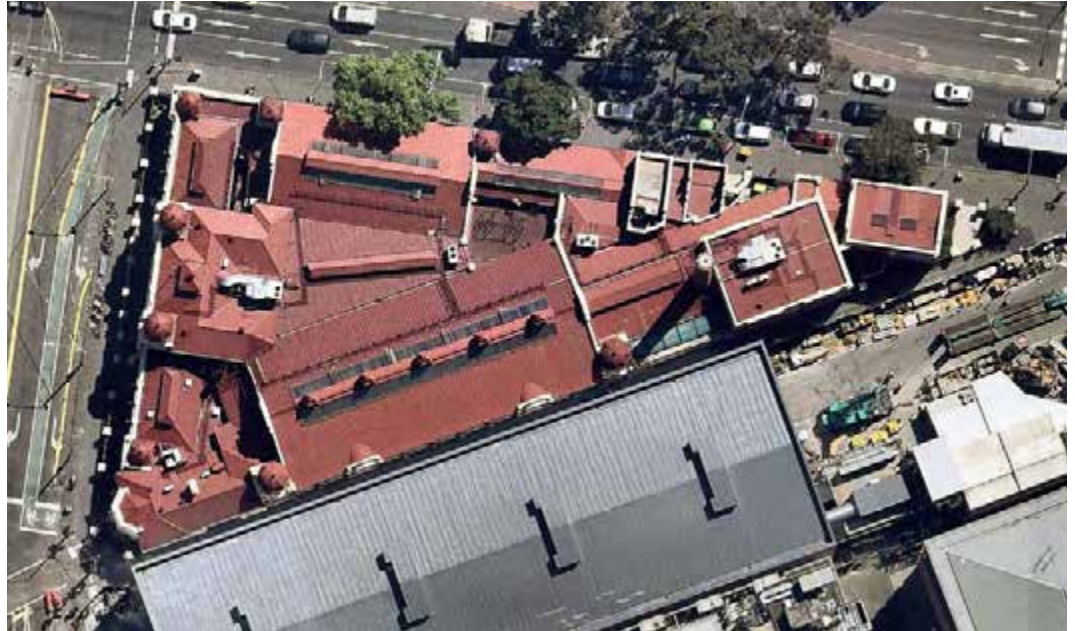
Figure 105 2018 aerial image of the City Baths, showing complex roof forms

As described in Chapter 3, the roof comprises original, modified and later components, although the original roof forms predominate; this can also be seen when comparing the current and 1945 aerial photographs at Figure 105 and Figure 106 respectively. The current steel roof cladding - including pitches with rolled seam detailing and others in corrugated steel - is not original having generally been replaced in a like-for-like manner as part of the 1981-3 works. The cupolas largely retain their original steel shingle cladding and detailing with some replacement. The 1980s roof components in the east of the site are clearly later.

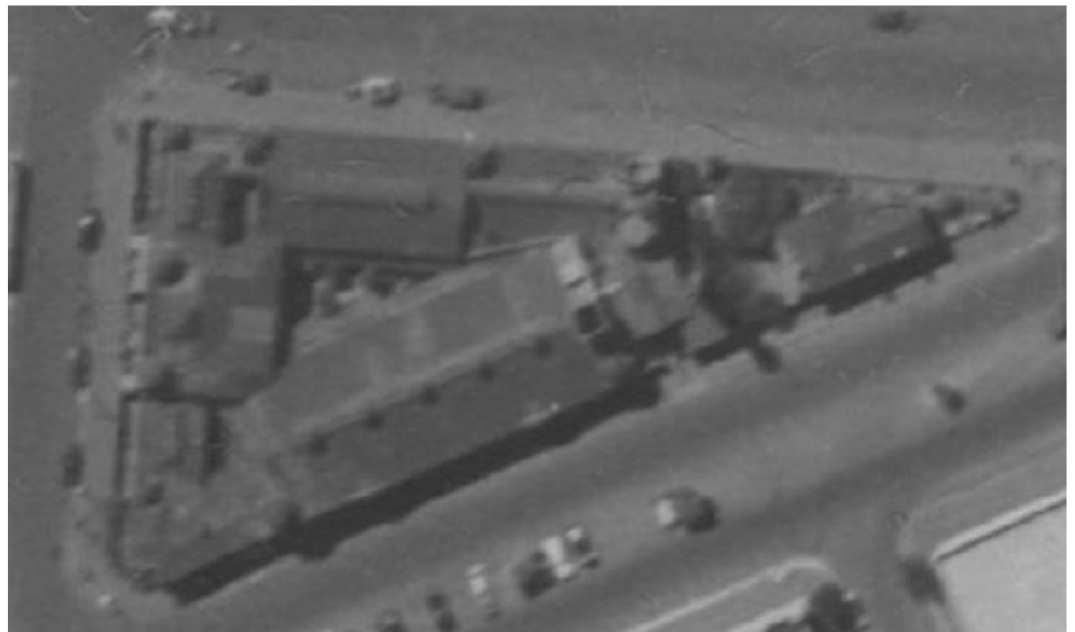
Figure 106 1945 aerial image of the City Baths, showing largely original roof forms
