Management report to Council**Agenda item 6.1****Melbourne International Flower and Garden Show proposed new licence - 2024 - 2029****Council****Presenter:** Katrina McKenzie, General Manager City Economy and Activation**30 August 2022****Purpose and background**

RE: Information for Melbourne International Flower and Garden Show (MIFGS) License

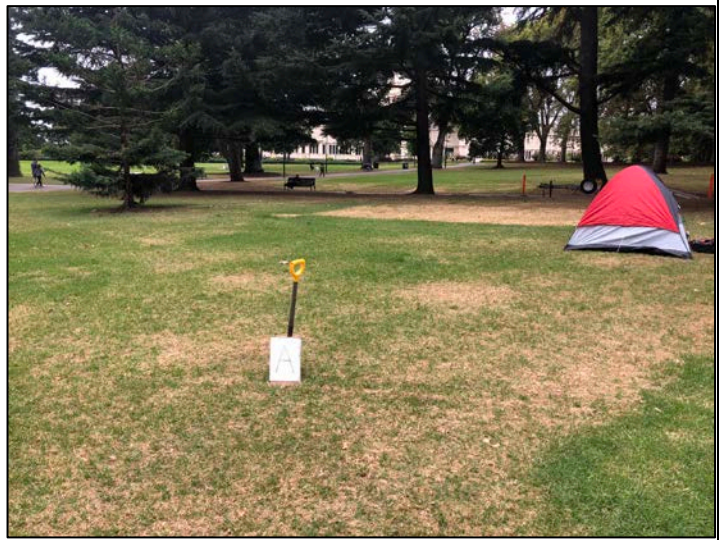
Pre-show – 22.5 cm

Post-show – 13.1 cm

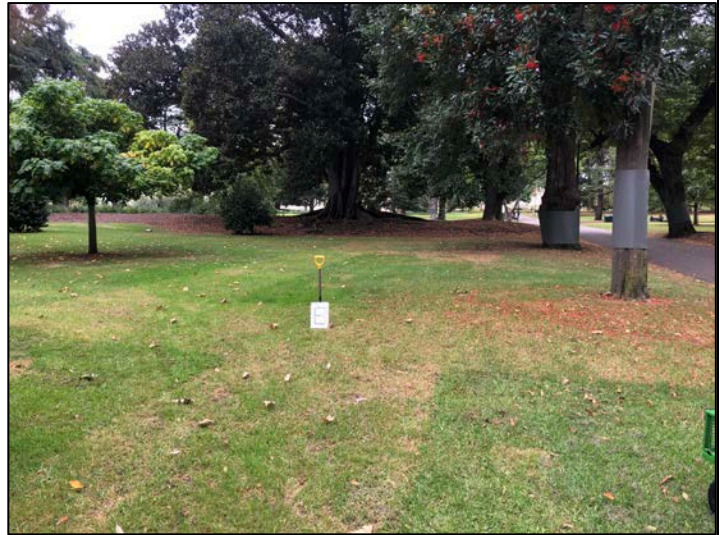
**Site B**

Mixed quality turf. Mixture of species, with varying levels of health between them. Browning off patches, some from mower scalping, some from dieback of certain grass species.

Pre-show – 7.5 cm

Post-show – 9.0 cm

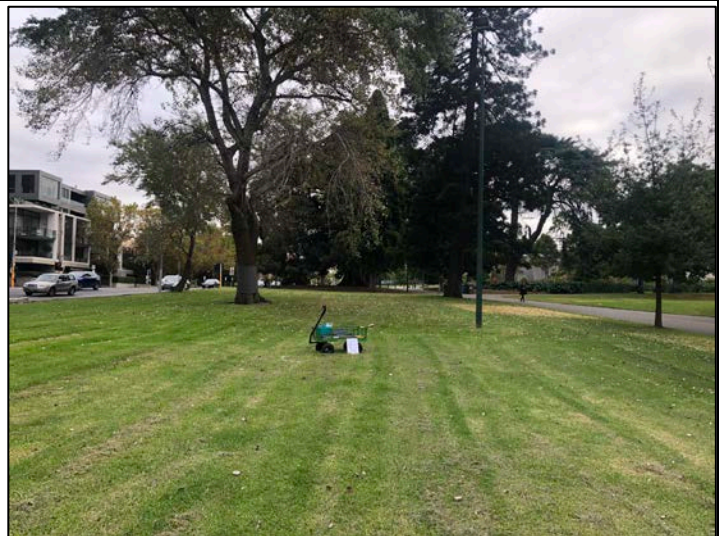
**Site C**

Turf dense, mid-green. Some brown patches, potentially dieback of cool season grass species.

Pre-show – 18 cm

Post-show – 9.2 cm

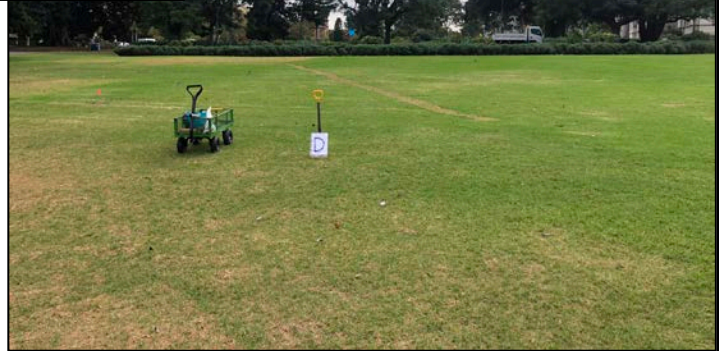
Site D

Turf dense. Uneven ground showing scalping by mower.
Soil: large gravel inclusions. Large chunk of basalt at base of second sampling hole (abandoned).

Pre-show – 17.3 cm
Post-show – 12.3 cm

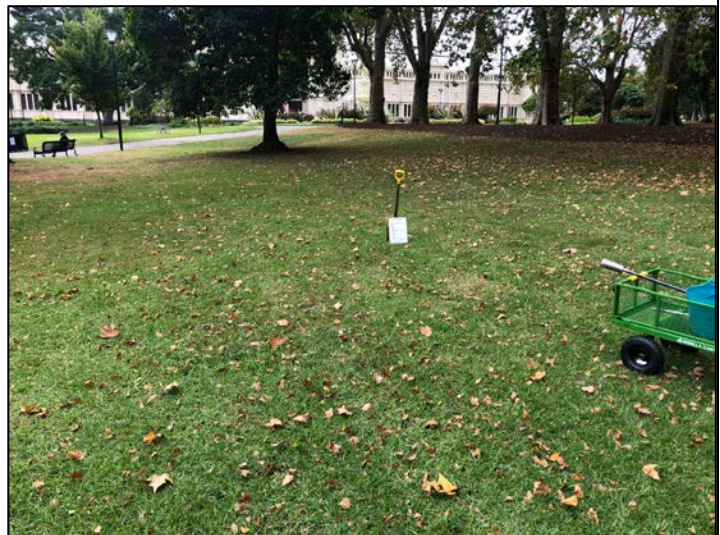
**Site E**

Turf finer, appears to have higher % of cool season grass species. Green and thick, though with some thin patches, possible mower scalping.

Pre-show – 10.9 cm
Post-show – 7.4 cm

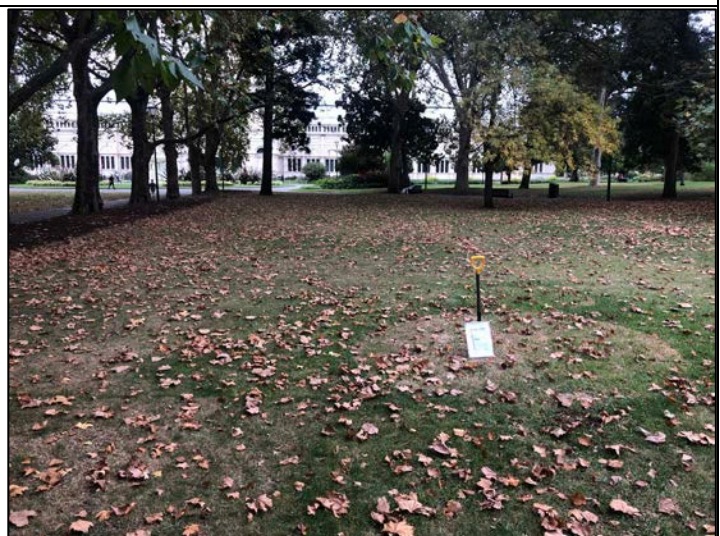
**Site F**

Moderate turf, partially shaded. Bare patches, sparse patches, though what was present was green and healthy. Some worn patches, new growth emerging.

Pre-show – 8.1 cm
Post-show – 6.4 cm

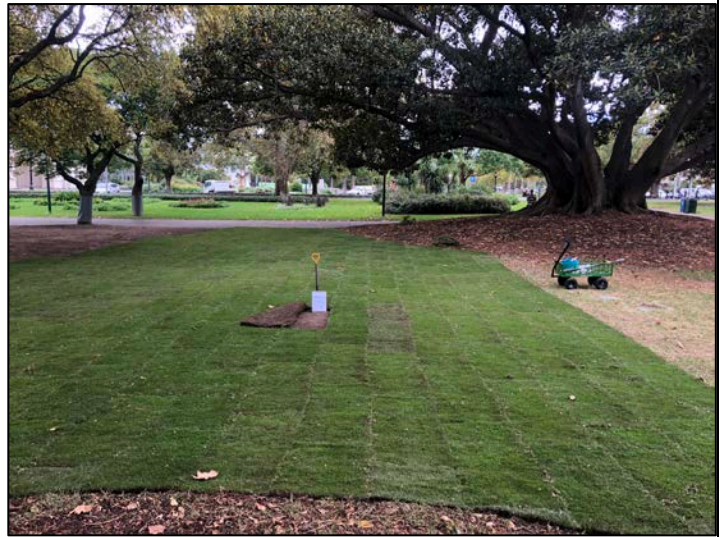
Site G

Partly shaded. New turf laid on morning of sampling.

Pre-show – 6.3 cm
 Post-show – 4.2 cm

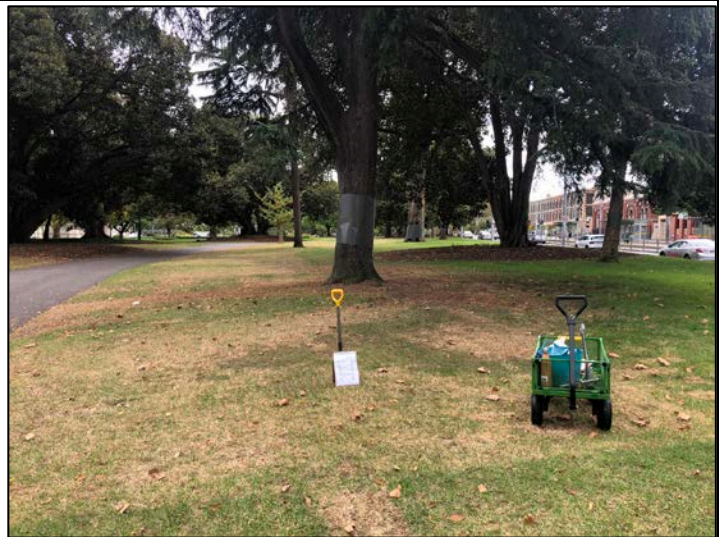
Site H

Open lawn, edged by shade trees. Browned patches with new growth emerging. Soil presented as more sandy than at other sites.

Pre-show – 5.8 cm
 Post-show – 5.8 cm

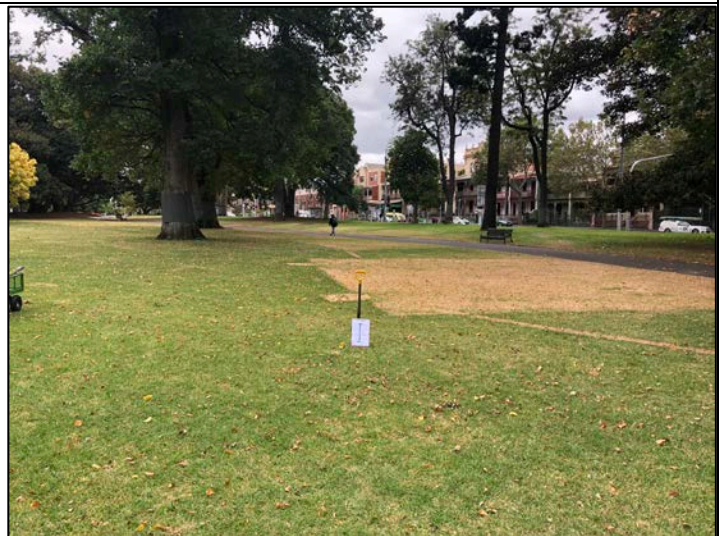
Site I

Open sunny position, turf thick. Patches of browning off from light exclusion.

Pre-show – 8.3 cm
 Post-show – 6.0 cm

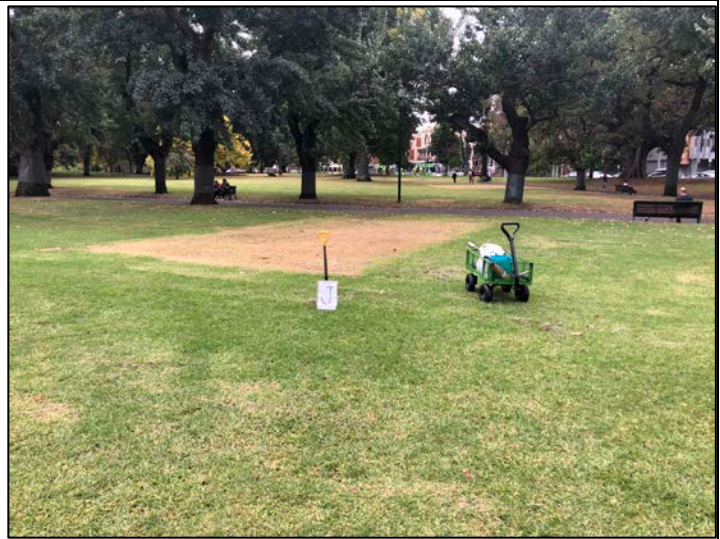
Site J

Thick, even turf, some mower scalping. Patches of browning off from light exclusion.

Pre-show – 14.8 cm

Post-show – 9.5 cm

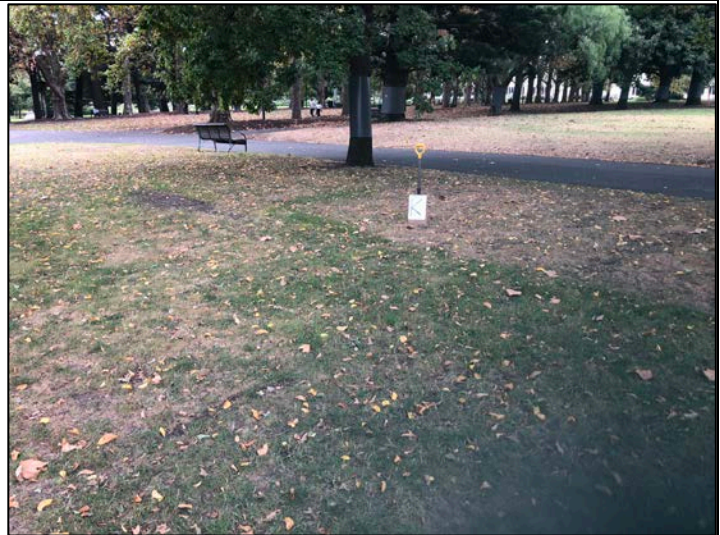
**Site K**

Turf patchy, moderately thick patches interspersed with sparse cover. A few areas of bare soil. Generally uneven ground with tree roots present at surface. All surface roots with existing mower damage.

Pre-show – 6.3 cm

Post-show – 4.8 cm

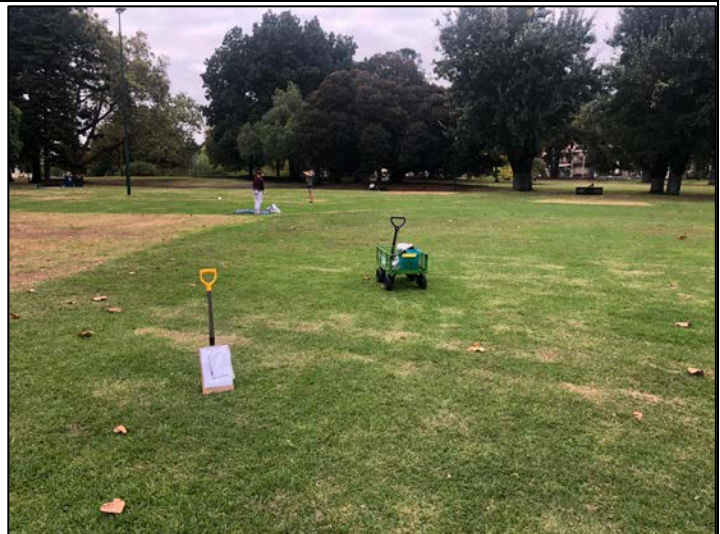
**Site L**

Open turf, dense. Varying textures due to species mix. Patches of browning off from light exclusion.

Pre-show – 11.8 cm

Post-show – 8.4 cm

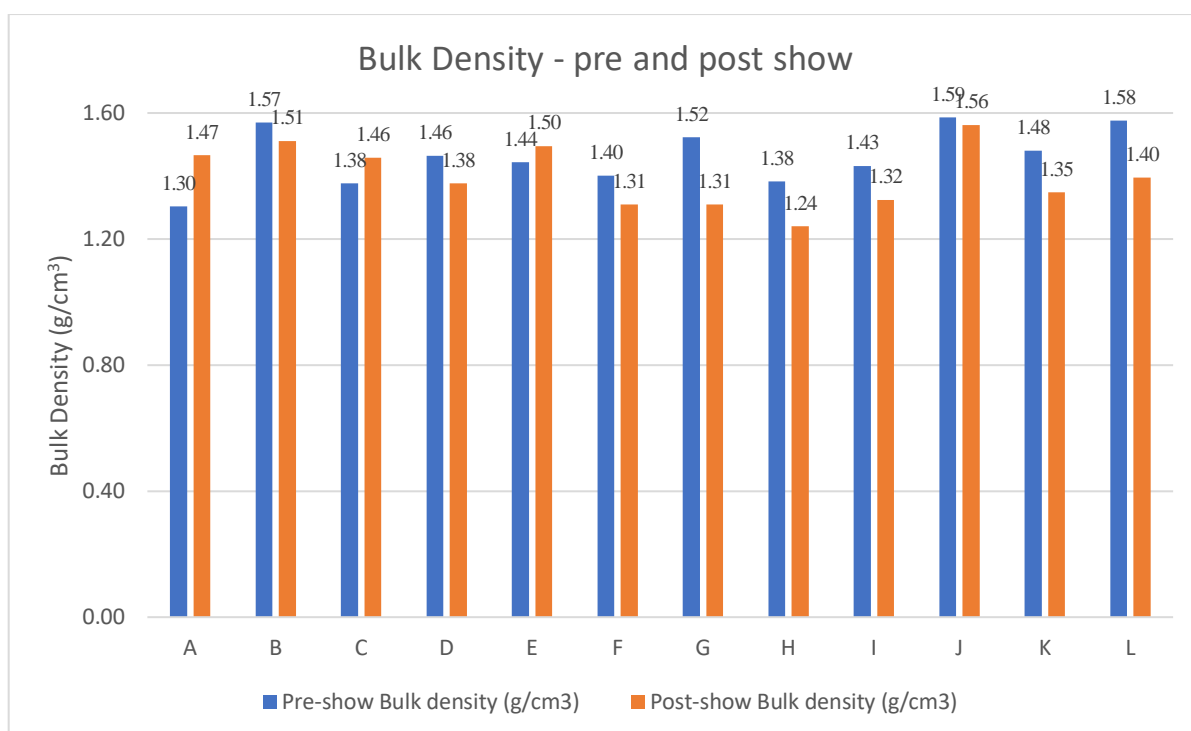
Figure 2: Bulk density values for each site, pre-show and post-show.

Before the staging of MIFGS the highest bulk density values for the site were 1.57, 1.58, and 1.59 g/cm³, at sites B, L, and J respectively. While higher than in the past, these bulk densities are still acceptable for the soil texture and site use, especially under irrigation. After the show the highest bulk densities recorded were 1.47, 1.50, and 1.56 g/cm³, this time at sites A, E, and J respectively.

As suggested in the pre-show report, it would appear that the slight increase in bulk density values from the 2019 is due to a change in sampling technique. The bulk density values recorded post-2022 show are very close to the pre-show values, some sites showing insignificant increases and some sites showing insignificant decreases (See Figure 2).

Overall the bulk density values for the site did not indicate an increase in soil compaction during the staging of MIFGS.

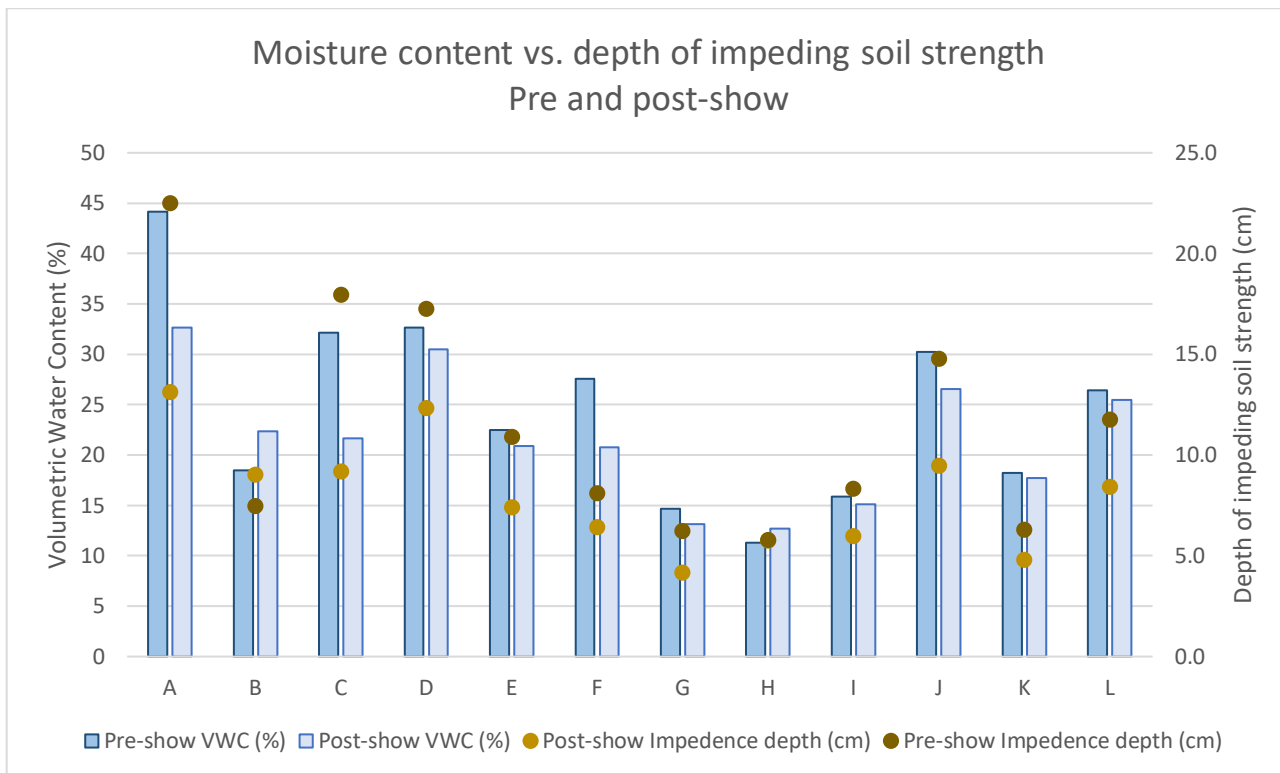
Figure 3: Moisture content and depth of impeding soil strength for each site.

Soil moisture levels tended to drop slightly across the site over the study period, though two sites (B and H) showed a slight increase. G, H, and I remained the driest sites, with values under 15% indicating they were still moving towards water content that could induce stress, especially in the turf. Pre-show Site H had the lowest volumetric water content (11%) and the turf at this site was showing rolled in leaf margins, a sign of water stress. Post-show Site H had actually shown a slight increase in water content to 13%, though this is still considered in the range of impending water stress. As per the before show results, the remaining sites had moisture contents in the readily available water range (10 – 1500 kPa suction).

In loose, well-aggregated soils, soil strengths of 2000 kPa occur at water contents close to the wilting-point. As soils become more compacted, the limiting soil strength is reached at higher water contents. At the Carlton Gardens, with generally moderate bulk densities measured across the site, the pre-show depth of impeding soil strength for each site was strongly correlated with the level of soil moisture at each site (see Figure 2). Where soil moisture was highest, the depth of soil without impediment was deepest. Post-show results indicated a continuation of this correlation. Where moisture content dropped, depth to impeding soil strengths became shallower.

Site B saw an increase in moisture content (18% to 22%) and an improvement in unimpeded depth (7.5 cm to 9.0 cm), as would be expected from the relationship between moisture content and soil strength. Site H had a very slight increase in moisture content (11% to 13%) and the unimpeded depth at this site remained the same.

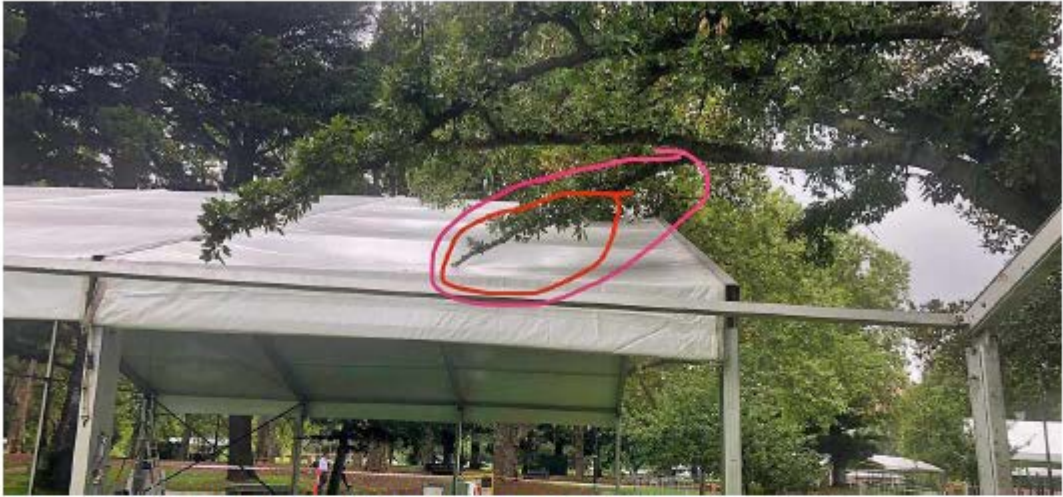
Photo 1: A branch that was inspected by CoM representative for removal.

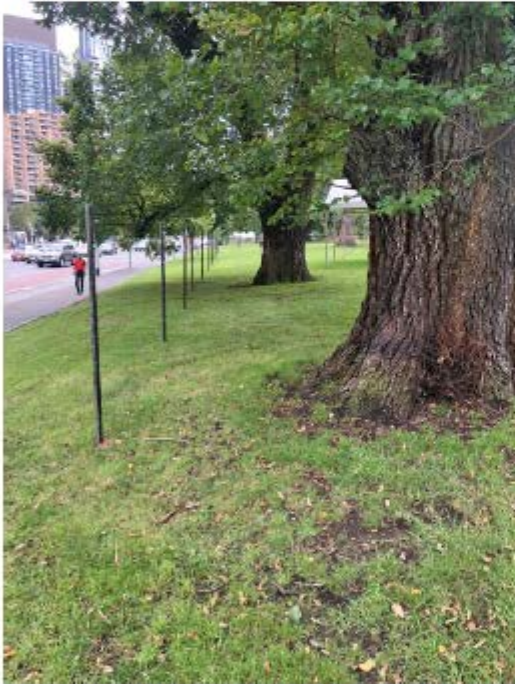
Photo 2: A view of the proximity of the external fencing posts to the trees (incident 1).

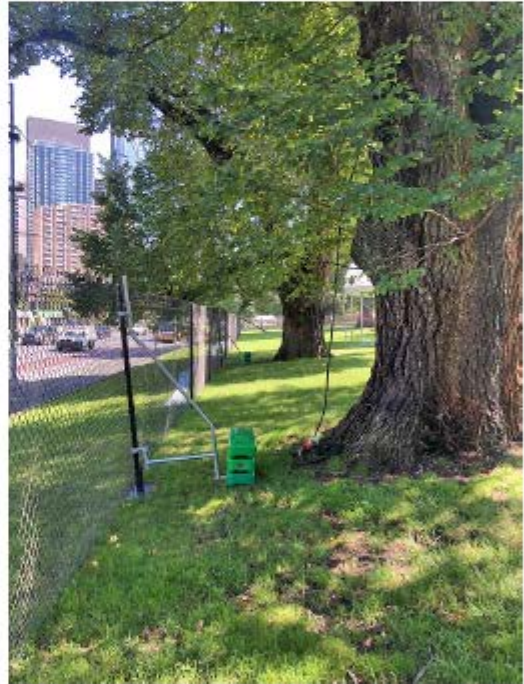
Photo 3: A view of the amended fence line treatment more in line with both the project arborist guidance and the TPP.

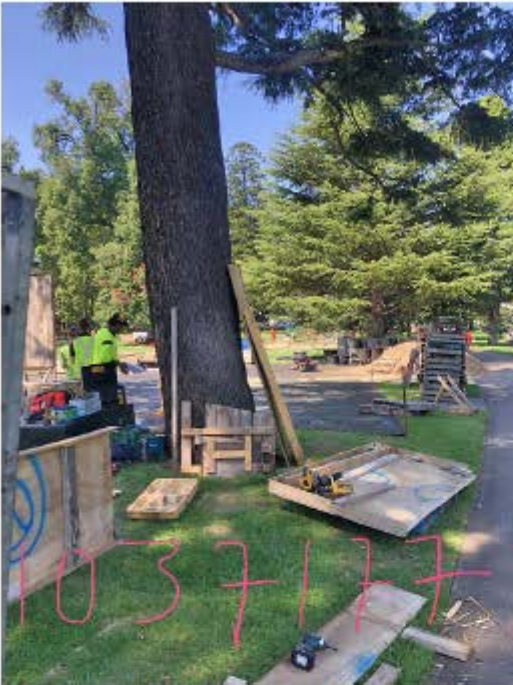
Photo 4: A view of a site where minor items were inappropriately stored near and against a tree (incident 4).

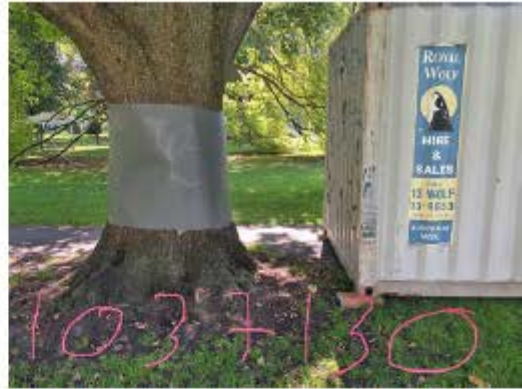
Photo 6: A shipping container placed inappropriately (incident 5).

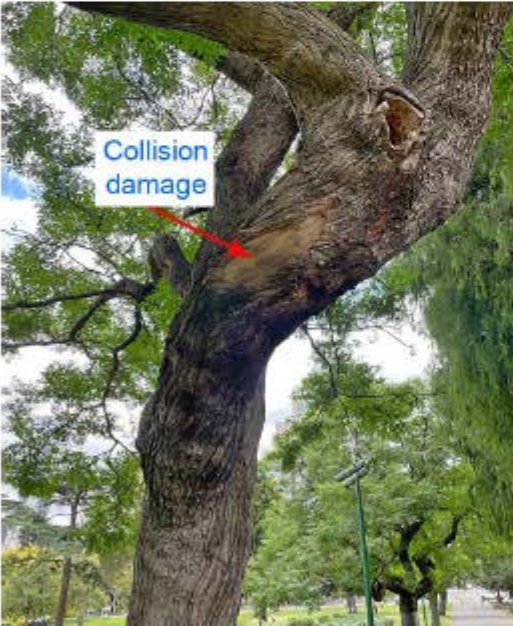
Photo 7: Possible collision damage to a major branch on Tree 1440714. It is unknown if this damage was made prior to MIFGS. The wound does not appear to be fresh based on the darker colouration but it would have been recent.

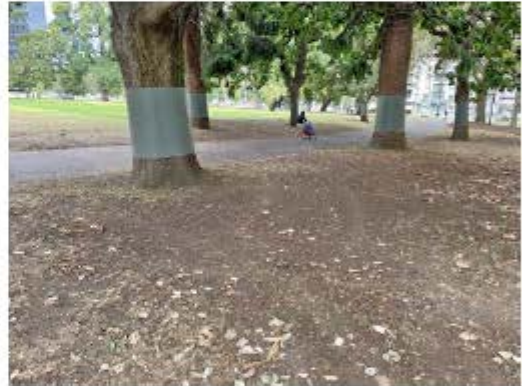
Photo 8: Vehicle tracks were noted, likely from a forklift, that traversed the ground near Trees 1036994.
